**CWA COMPLIANCE EVALUATION INSPECTION REPORT
U.S. ENVIRONMENTAL PROTECTION AGENCY, REGION 5**

Purpose: Compliance Evaluation Sampling Inspection

Facility: FOIA Exemption (b) (6) Pork Farm
3640 Honeysuckle Road
Coulterville, Illinois 62237

Date of Inspection: November 9, 2011

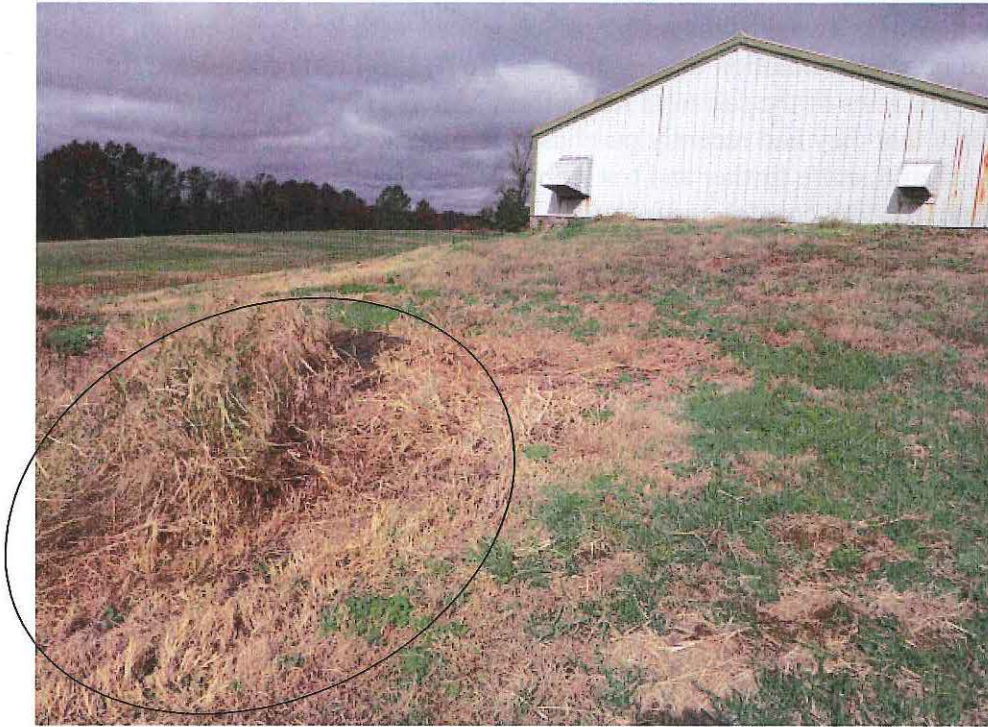
EPA began the walkthrough of the farm heading south from the machine shed. The first barn encountered is named "Wisconsin". Wisconsin is a nursery building with a capacity of 380 swine. It was empty on the date of the inspection. This building has a slotted floor that allows manure to run beneath and to an exterior manure pit. The exterior manure pit was full and had plant growth on the surface, but no signs of discharge were seen on the day of the inspection (Photos 1 & 2).

Photo 1. Facing northwest. Note exterior manure pit with vegetation covering most of top and the building named "Wisconsin" in the upper right corner.

1. The exterior manure pit south of Wisconsin is full and was in need of emptying.
2. The hose used to pump manure from the solids settling basin has leaked manure onto the ground and had discharged to the unnamed tributary.
3. There was no depth marker located on the manure storage ponds.
4. The lack of a Nutrient Management Plan or equivalent records showing compliance with the requirements of the agricultural storm water discharge exemption makes any run-off from land application fields subject to NPDES violations.

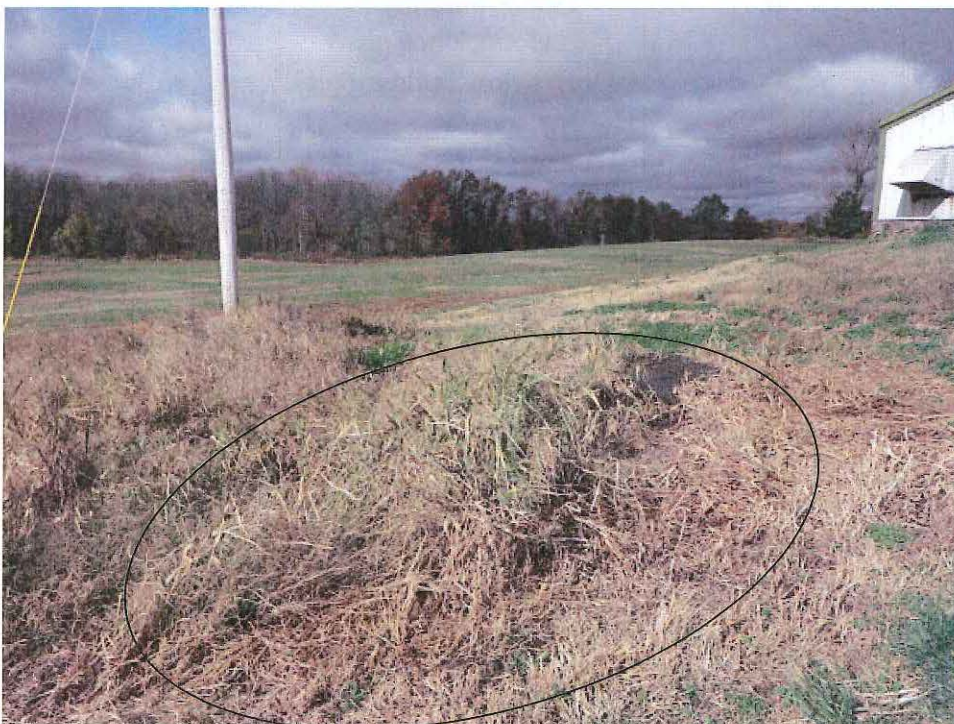
Photo 2. Facing northwest. Note exterior manure pit with vegetation covering most of top and the building named "Wisconsin" in the upper right corner.

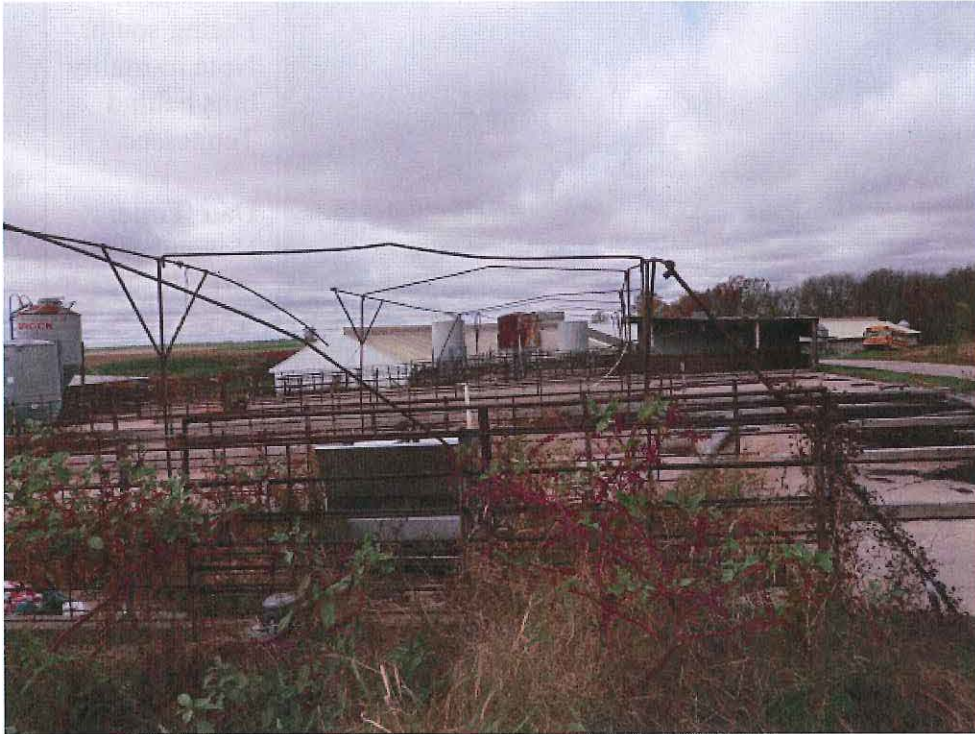
The next building encountered, "Georgia" has a 500 animal capacity and an 8ft x 12ft x 120ft manure pit below the building. West, across the driveway, sat the foundation and remains of "Kentucky" which had the roof blown off in a storm. Kentucky was used as recently as the summer of 2011; however, **FOIA Exemption (b) (6)** stated that they planned to find an alternative use for the concrete pads and would no longer be using the area for storing animals (Photos 3 and 4).

Photo 3. Facing West. The remains of Kentucky; no longer used as a livestock facility.

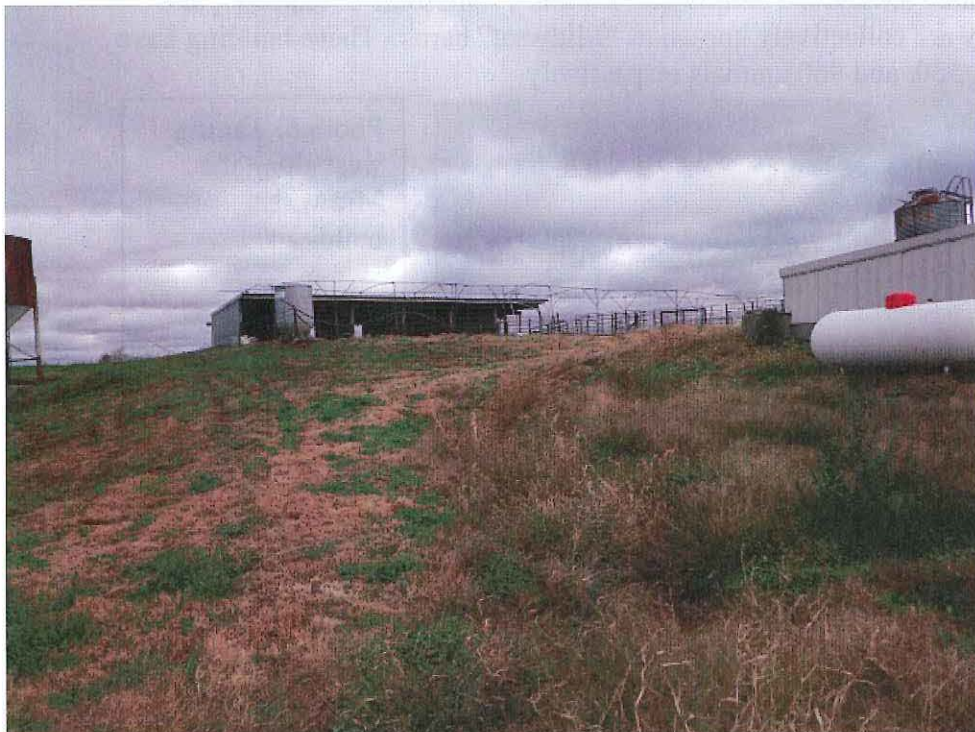
Photo 4. Standing south of "Tennessee", facing northeast. The remains of Kentucky; no longer used as a livestock facility. Tennessee is visible to the right.

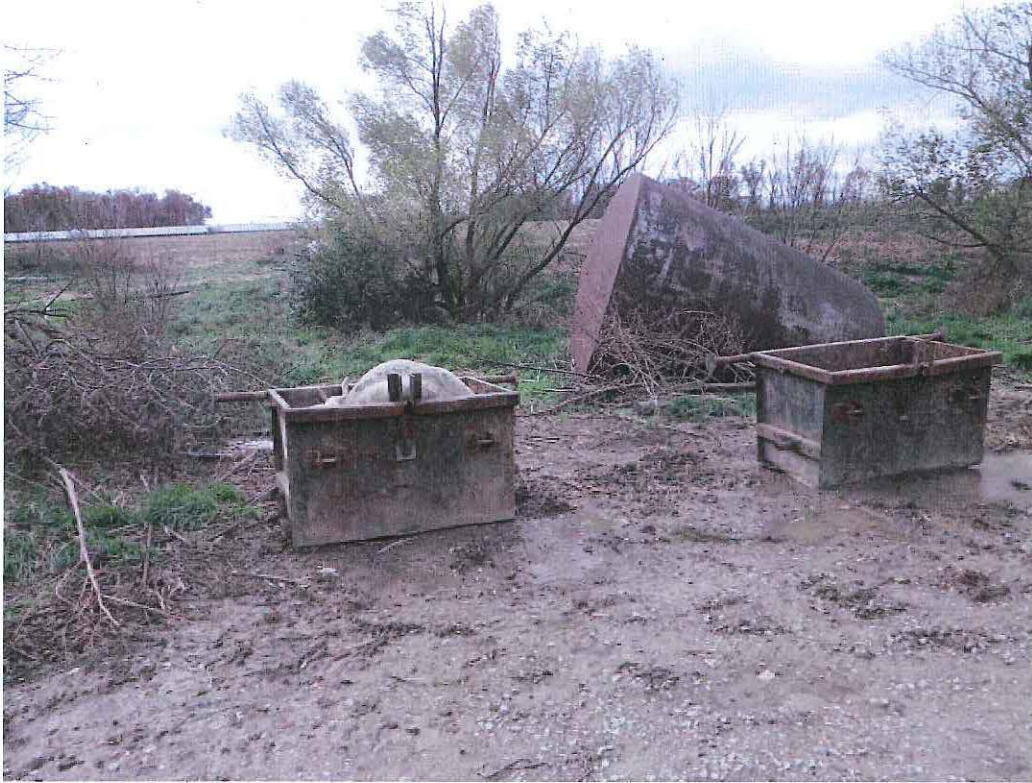
EPA continued south to “Tennessee”. This building has 8ft x 12ft x 100ft pit and a 350 animal capacity. The mortality bins, provided by Darling International, are located behind this building (Photo 5). Once filled, the bins are moved to a pickup location and Darling International is contacted.

Photo 5.
Facing south.
Note mortality
bins behind
Tennessee.

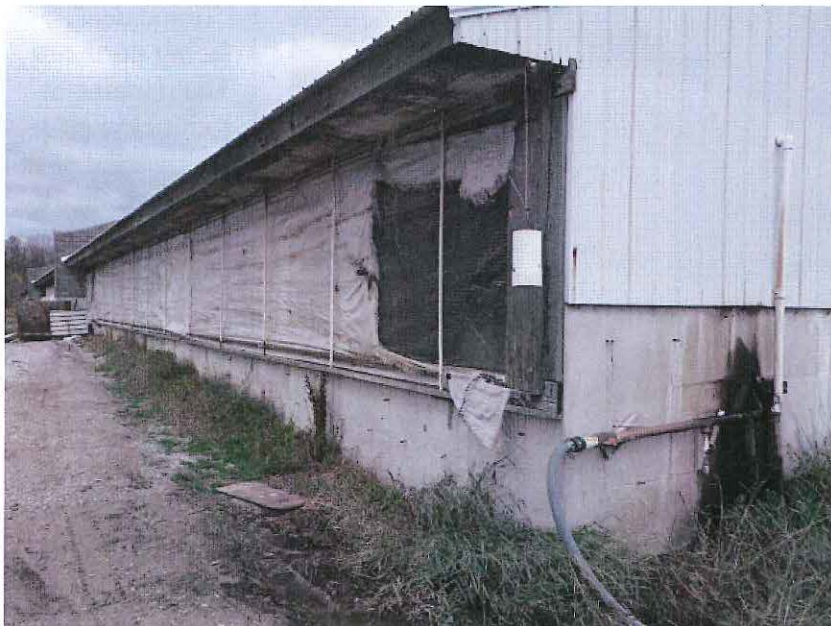
Turning West, EPA walked around the conjoined “Illinois”, “Missouri”, “Kansas”, and “Colorado” barns. They are collectively known as “Midwest” barns. These building have capacities of 550, 1100, 550, and 960 animals respectively.

Photo 6. Facing
west along the
Midwest
buildings.

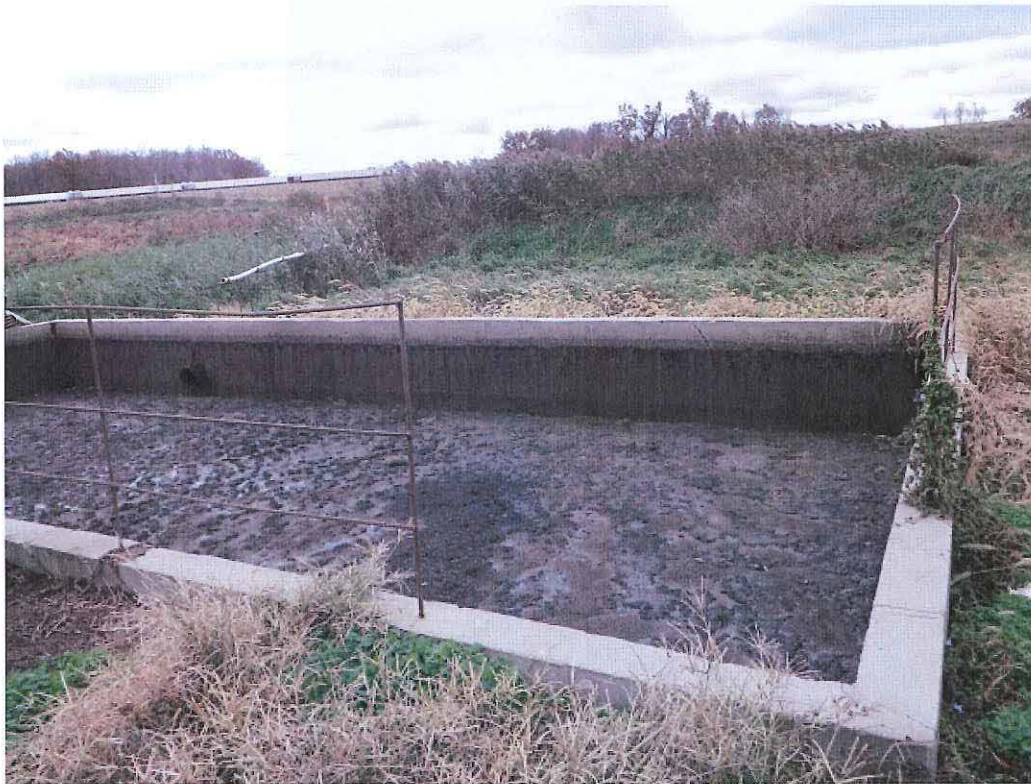
There is a two foot deep gravity flow pit beneath these buildings that flow to an exterior solids settling basin. This settling basin is located on the north side of the unnamed intermittent tributary that runs through the facility. The effluent from the solids settling basin is pumped to the Stage 1 manure storage pond. FOIA Exemption (b) (6) stated that the settling basin was originally designed to use a submersible pump with an automatic on/off float and be pumped through PVC pipes running above the surface; however, after several pumps failed, this system was abandoned. An external pump and hose are now employed. The hose to which the pump is attached is removed and laid on the ground when the pump is needed elsewhere. A portion of the manure remaining in the hose after pumping had discharged onto the ground around the hose and a pathway of dead vegetation was evident from where the hose was laid on the ground, to the unnamed intermittent tributary (Photos 7-12), which EPA inspectors observed at the time of the inspection.

Photo 7. Facing south behind the Midwest buildings. Manure solids settling basin. Manure storage ponds behind the basin.

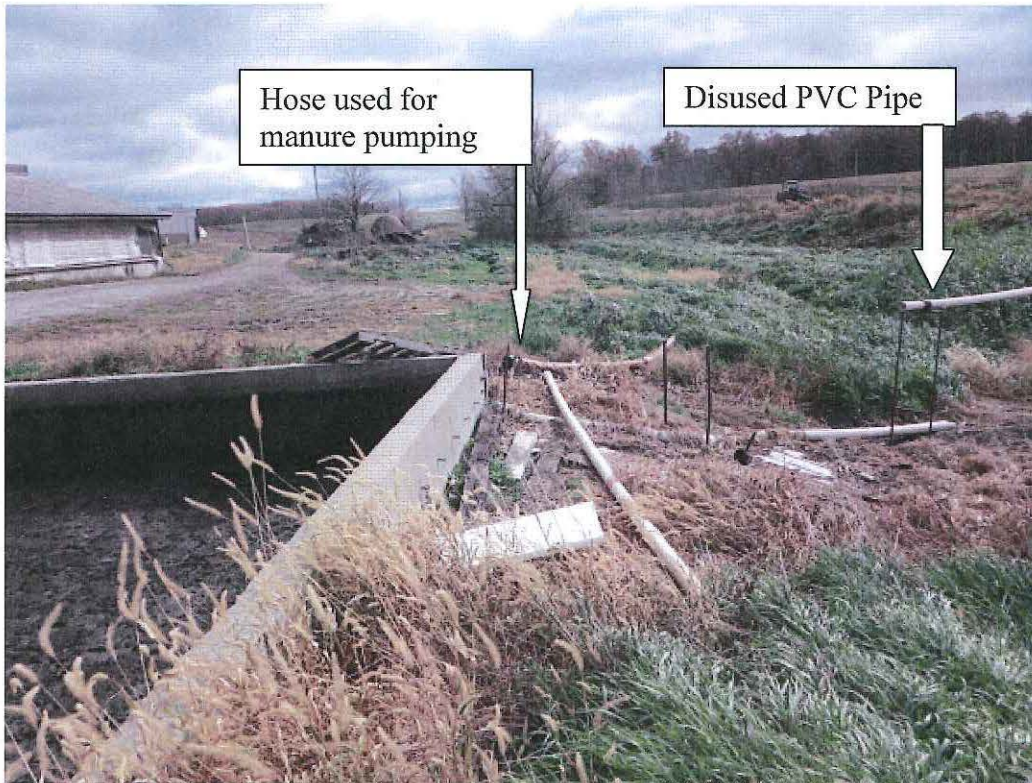
Hose used for
manure pumping

Disused PVC Pipe

Photo 8. Facing east. Manure settling basin. PVC piping that is no longer used along with the hose that is currently used to pump liquid to ponds.

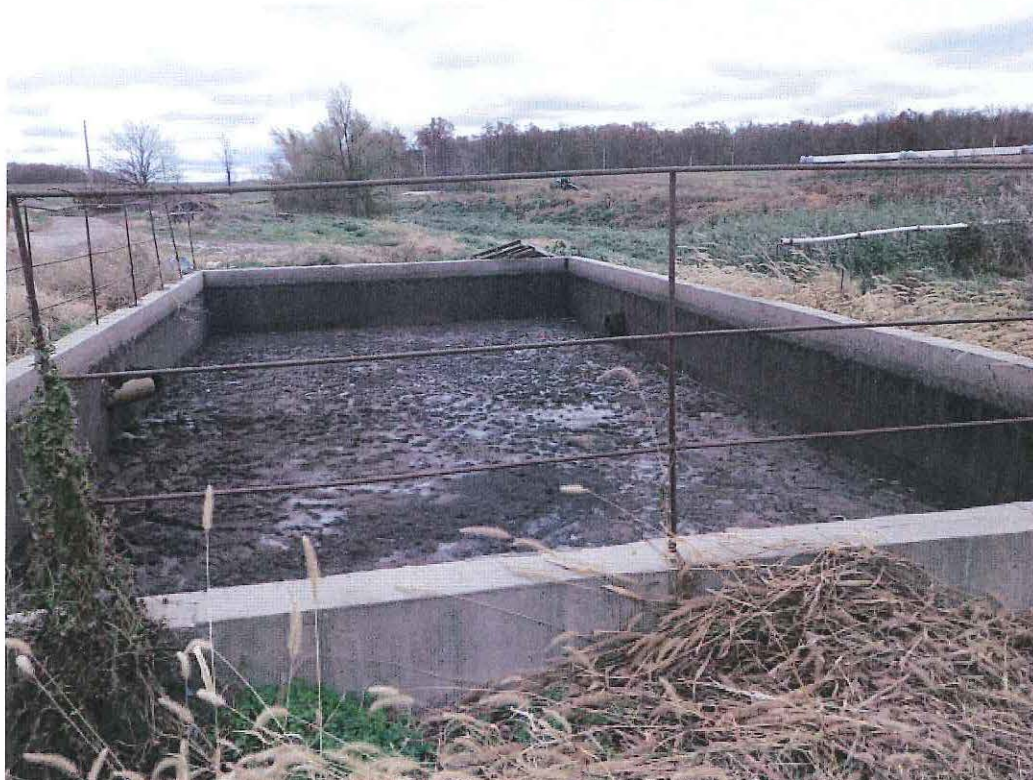
Photo 9. Facing east on south side of manure settling basin.

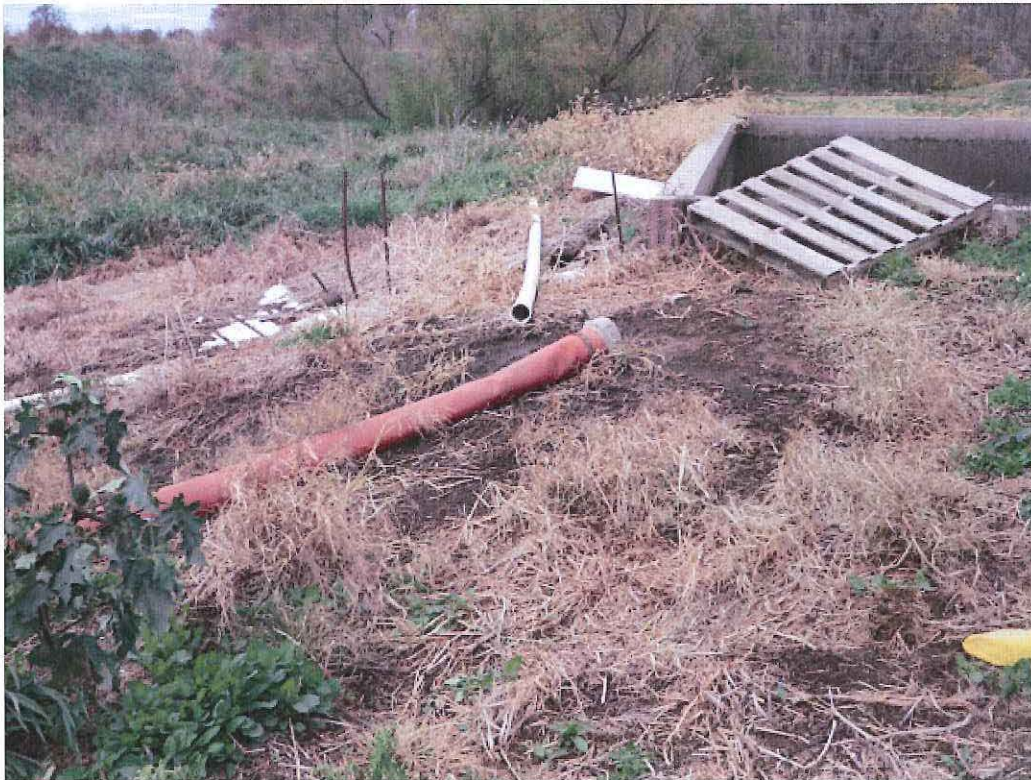
Photo 10. Facing west. Solids settling basin and hose used to pump liquid manure to ponds. Note vegetation burn out.

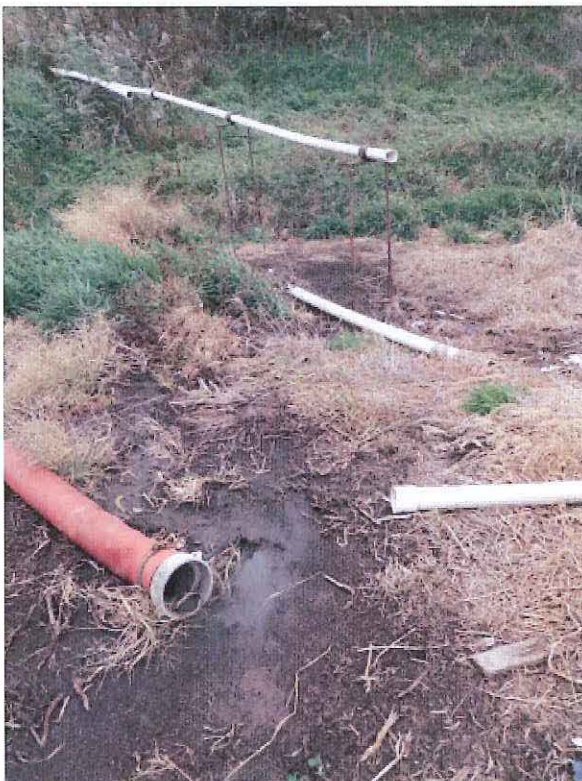
EPA observed during the inspection that the hose used to pump manure from the solids settling basin has leaked manure onto the ground. Sampling conducted during the inspection indicates that pollutants have been discharged into the unnamed tributary that runs through the facility. The unnamed tributary is a water of the United States, and thus any discharge of pollutants into the tributary without a permit violates Section 301(a) of the CWA.

Photo 11. Facing south. Hose used to transfer manure to pond and apparent discharge and pathway on ground.

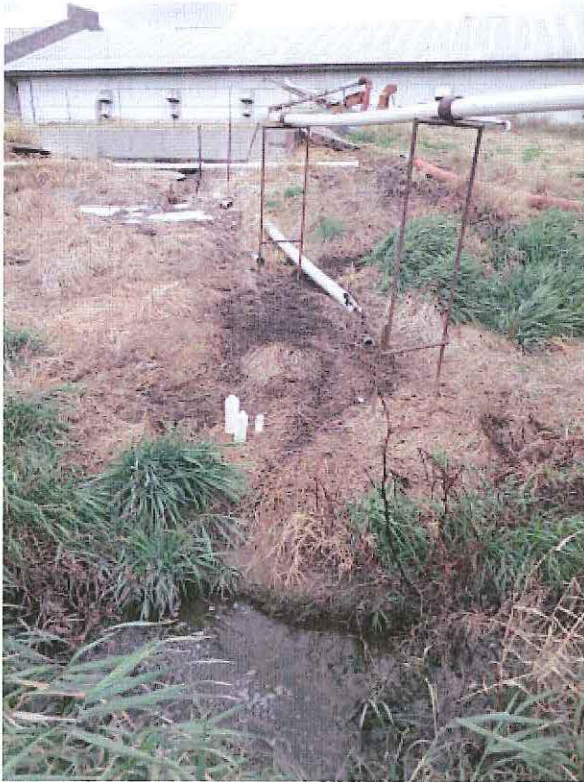
Photo 12. Facing north from south side of unnamed intermittent tributary. Note apparent discharge pathway to tributary.

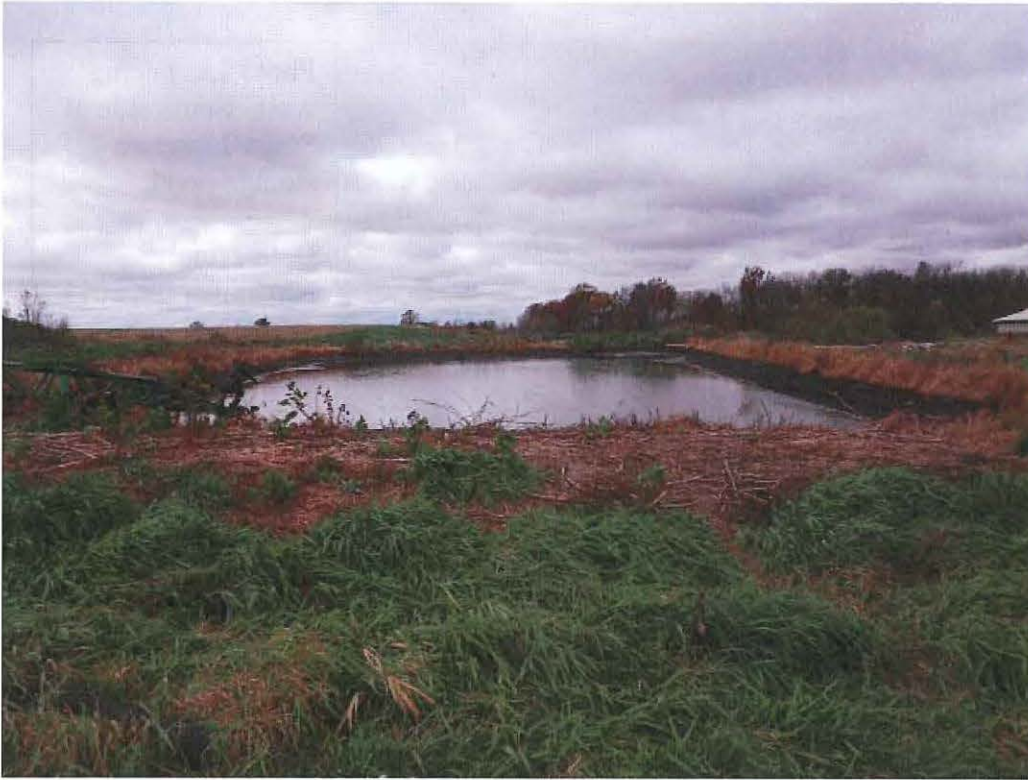
EPA continued the inspection by walking around the Stage 1 and Stage 2 manure storage ponds. The west and northwestern berms of the Stage 2 pond had some woody growth. **FOIA Exemption (b) (6)** stated that they intended to add soil to the slopes of the pond to change the slope to a manageable and mow-able angle. EPA walked entirely around both ponds. No depth markers were installed. The ponds were near capacity and **FOIA Exemption (b) (6)** stated that they intended to begin pumping their manure storage ponds soon. A berm to the south of the Stage 1 pond directs the run-off coming from the field to the south toward the unnamed intermittent tributary running through the facility. **FOIA Exemption (b) (6)** stated that in the summer of 2011 some field run-off made it to the pond causing it to over top its banks. **FOIA Exemption (b) (6)** stated that the berm had been modified and that the field run-off could no longer enter the ponds.

Photo 13. Facing west. Stage 1 of the manure storage ponds.

1. Vegetation around the berms was not mowed, so that owner/operator of the facility could make an adequate determination of the conditions of the berm.

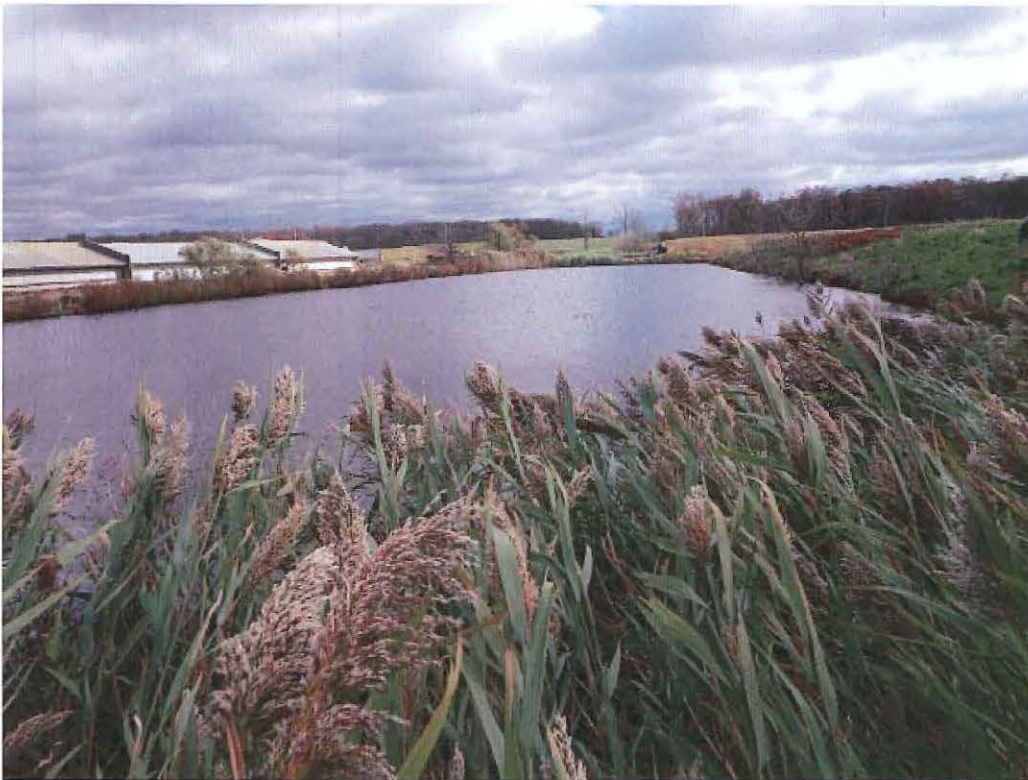
Photo 14. Facing east. Stage 1 manure storage pond from west side.

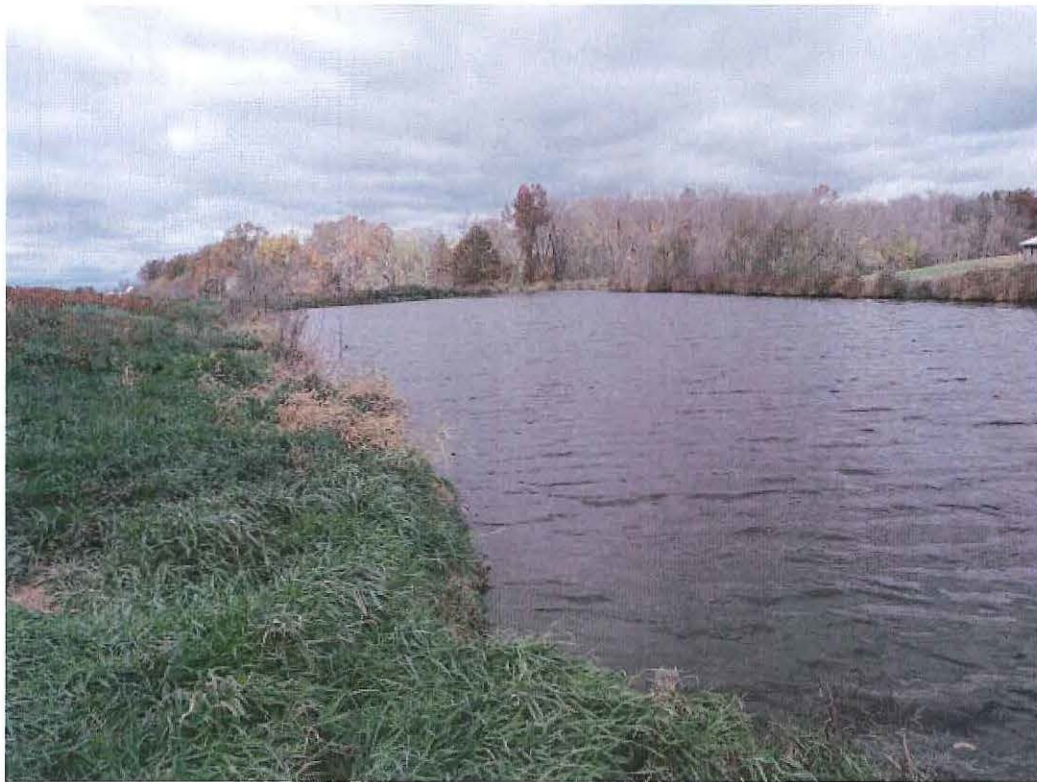
Photo 15. Facing west. South side of Stage 2 manure storage pond.

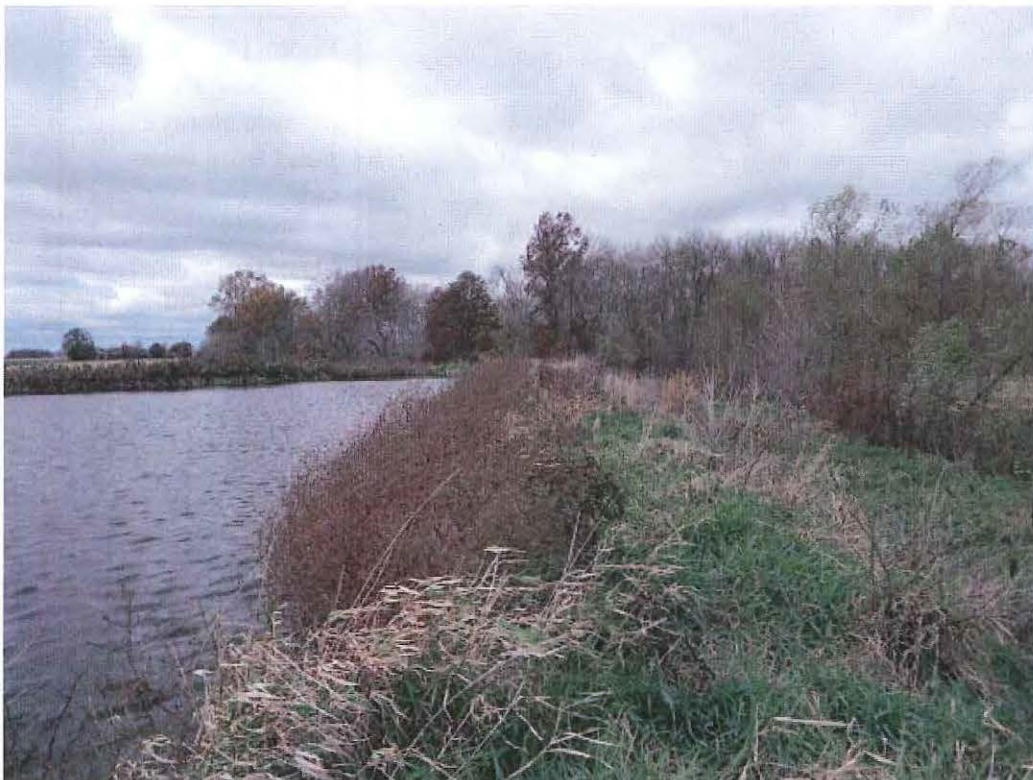
Photo 16. Facing west. North side of Stage 2 manure storage pond.

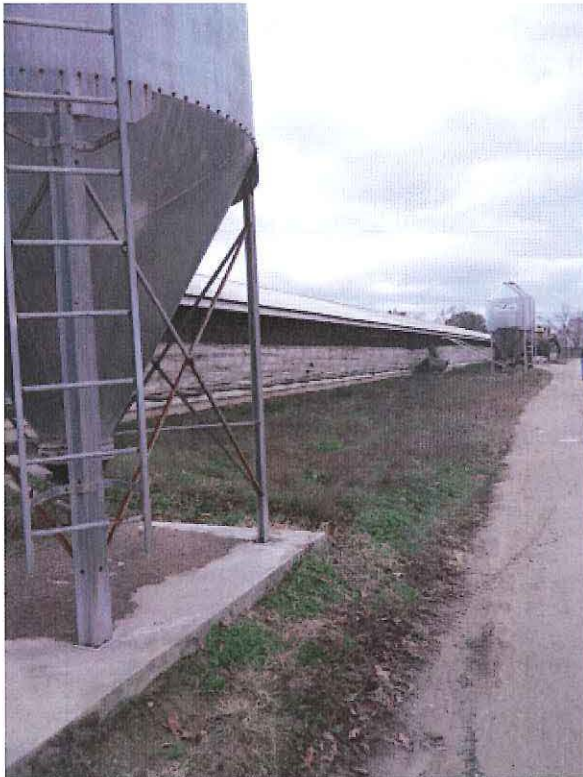
EPA continued south to the "Texas" building. Texas is comprised of four sections each with an animal capacity of 600 swine. There is a 40ft x 488ft x 8 ft manure pit beneath Texas. EPA walked entirely around Texas.

Photo 17. Facing west.
North side of Texas
buildings. Note feed
storage structures.

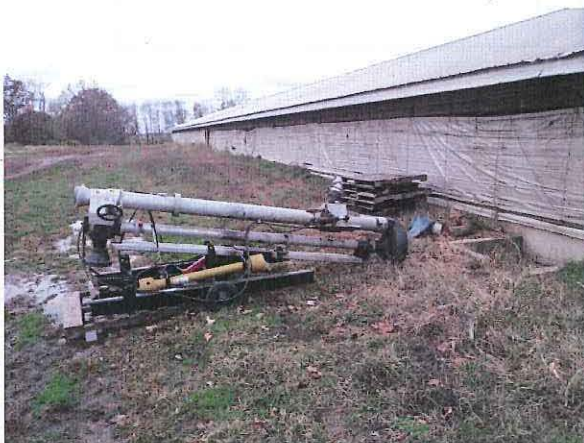
Photo 18. Facing west. South
side of Texas buildings. Note
pump used to evacuate manure
from pit beneath building.

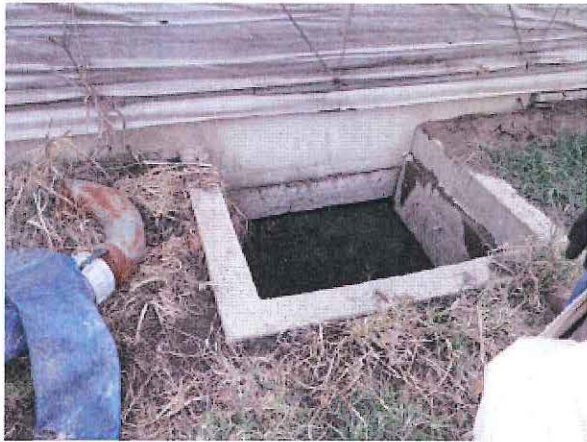
Photo 19. Facing north. An access point for pumping manure from the pit on south side of Texas building.

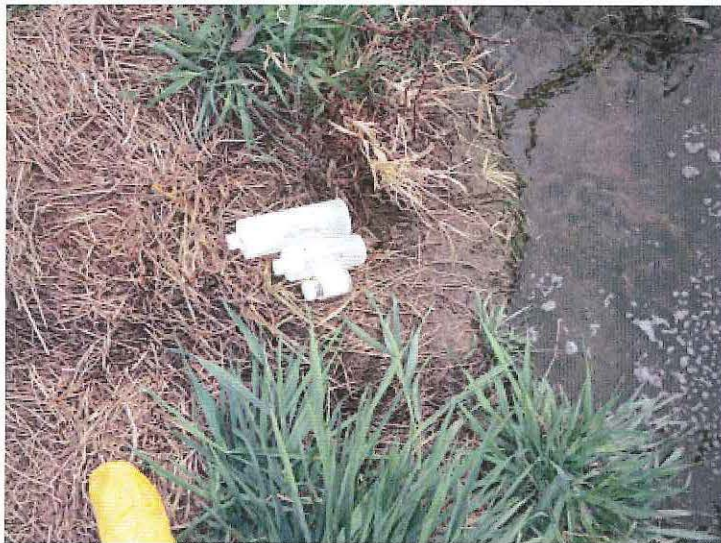
EPA returned to the settling basin and discussed with [FOIA Exemption (b) (6)] that samples were going to be taken and EPA offered to split the samples with him. [FOIA Exemption (b) (6)] declined. EPA took one sample, S01, from the water in the unnamed intermittent tributary at the point where the effluent from the manure hose seemed to have previously entered.

Photo 20. S01, at apparent confluence of manure pathway and unnamed intermittent tributary.

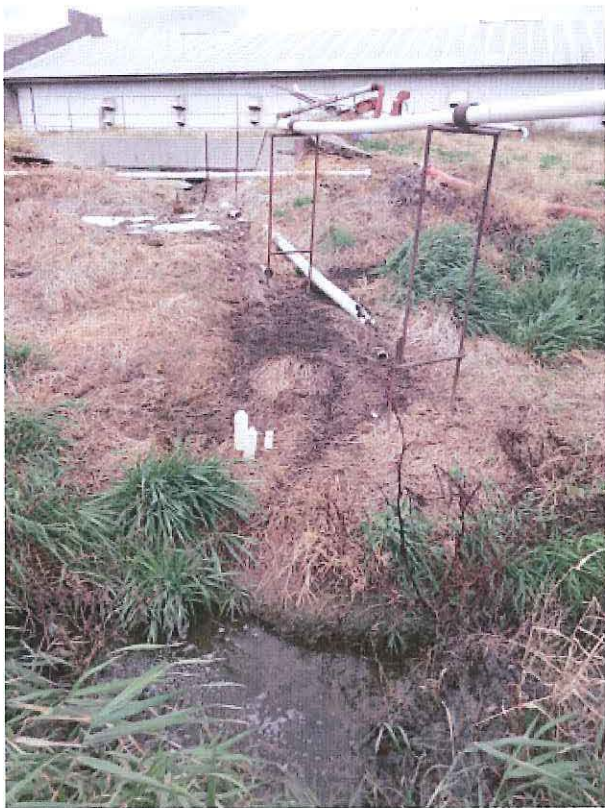
Photo 21. Sample S01, "Sample Location" taken at apparent confluence of manure pathway and unnamed intermittent tributary.
